*H*astings' E. Second Street Historic District is one of the most intact historic Main Streets in Minnesota. Over twenty years of preservation effort by property owners and the City of Hastings is evident in the restored storefronts and attractive facades of the district. Today, downtown Hastings offers many types of retail, office and residential space in its historic buildings.

Historic Commercial Buildings

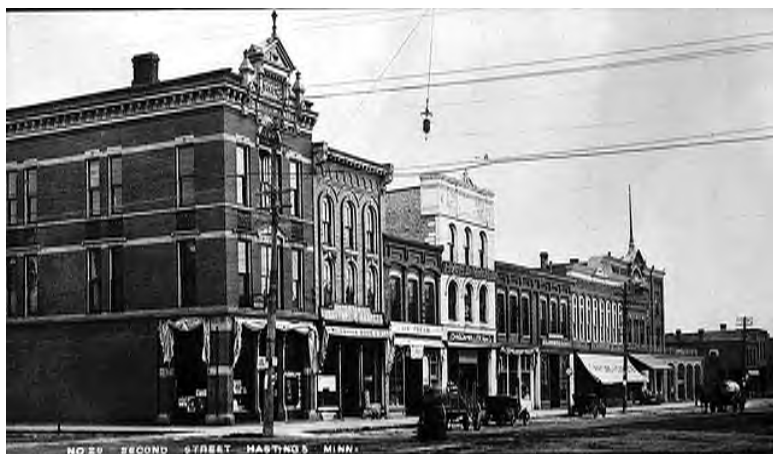
The east side of E. Second Street, 1885.

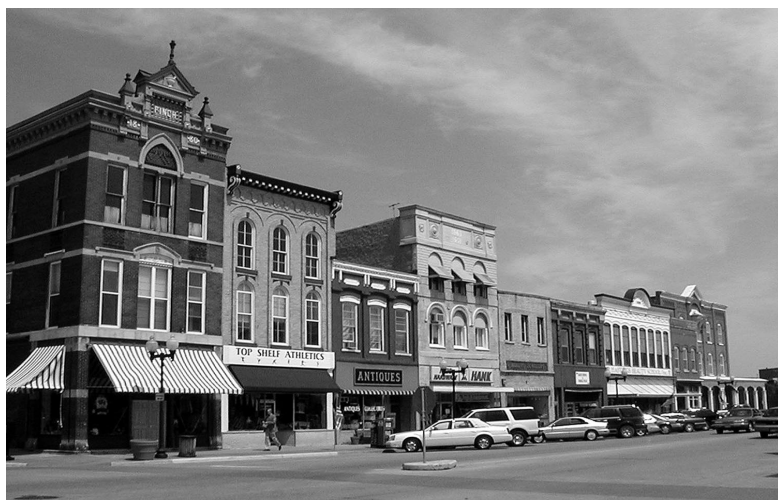
The east side of E. Second Street, 2002.

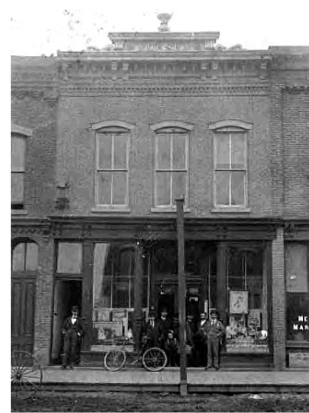
If possible, use historic photographs to guide exterior renovations. At right is the Reissner Building, 210 East Second Street. Cast iron columns divide the bays of the storefront; the top of the stepped sheet metal parapet is decorated with a metal urn. (Photo 1900; MHS.)

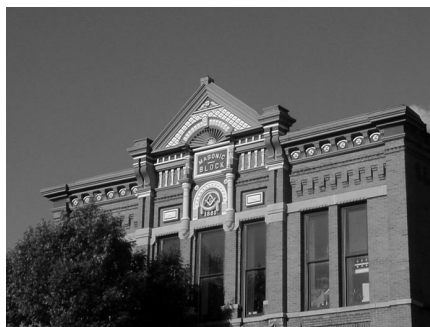
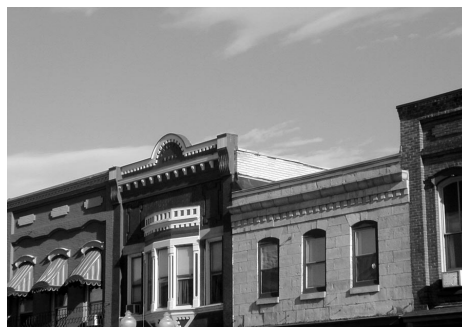
Late nineteenth-century commercial facades and details in the E. Second Street Historic District.

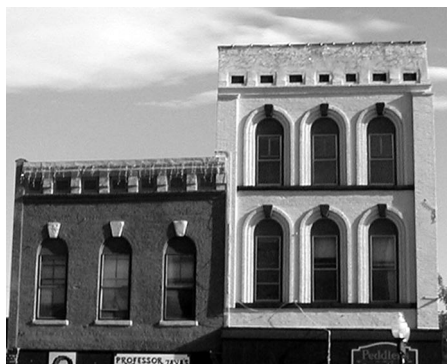
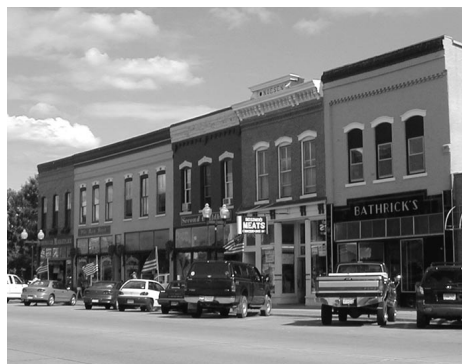
Early twentieth-century buildings often had geometric ornament like that shown at left.
